## MEXICO:

A path  
to resilience

**September 2017:**  
inside the two earthquakes

**SURA's post-seismic  
method:**  
going beyond damages

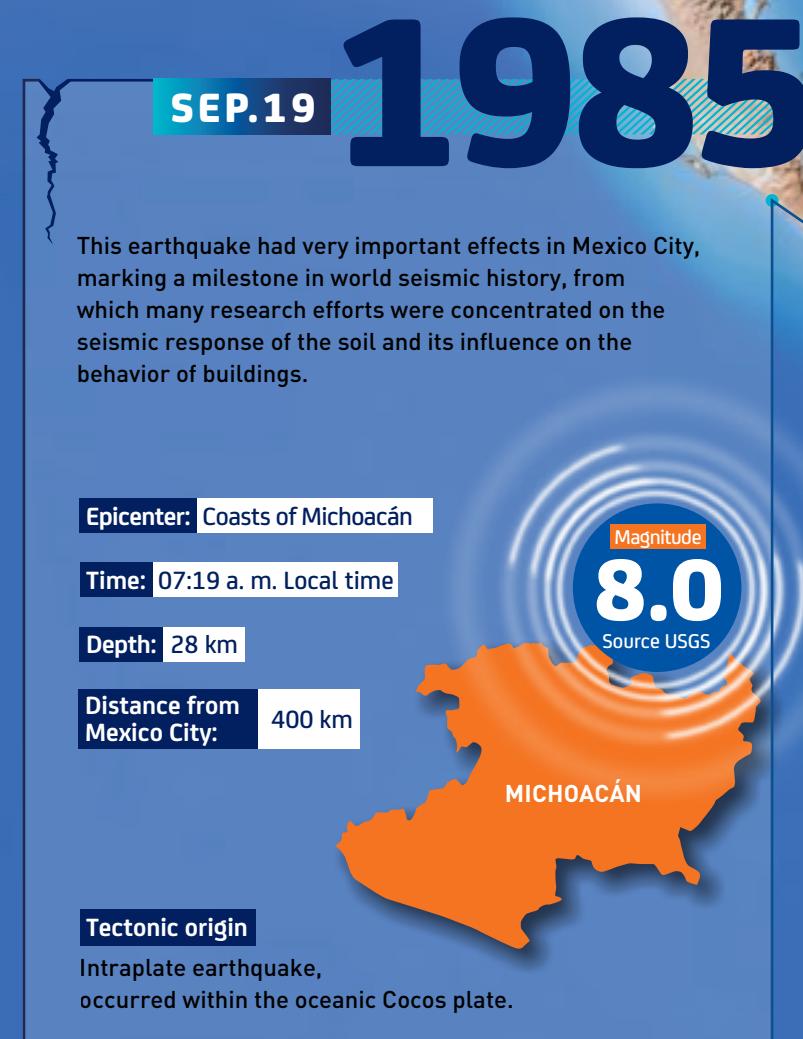
↓  
The great Michoacán earthquake of magnitude 8.0 (Mw), September 19, 1985, occurred in the central region of the Mexican Pacific coast, almost 400 km from Mexico City. This earthquake released 32 times more energy than the earthquake of September 19, 2017.

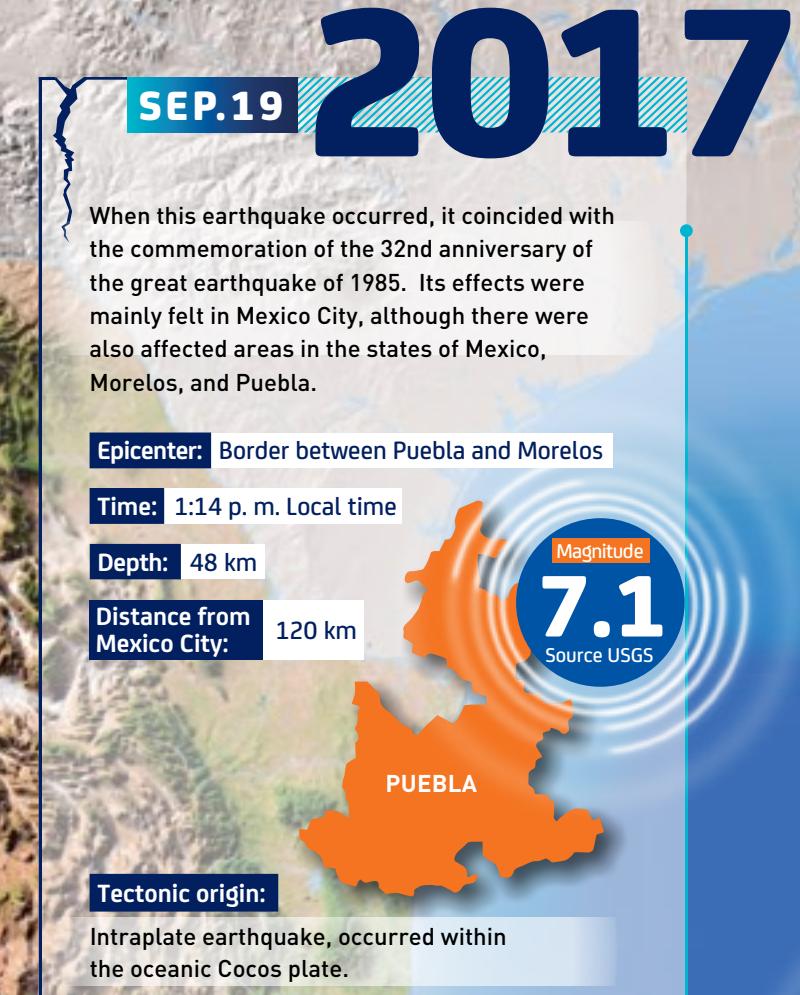
↓  
The earthquake of September 19, 2017, showed important advances in Mexican earthquake engineering since 1985, and marked a new challenge towards resilience.

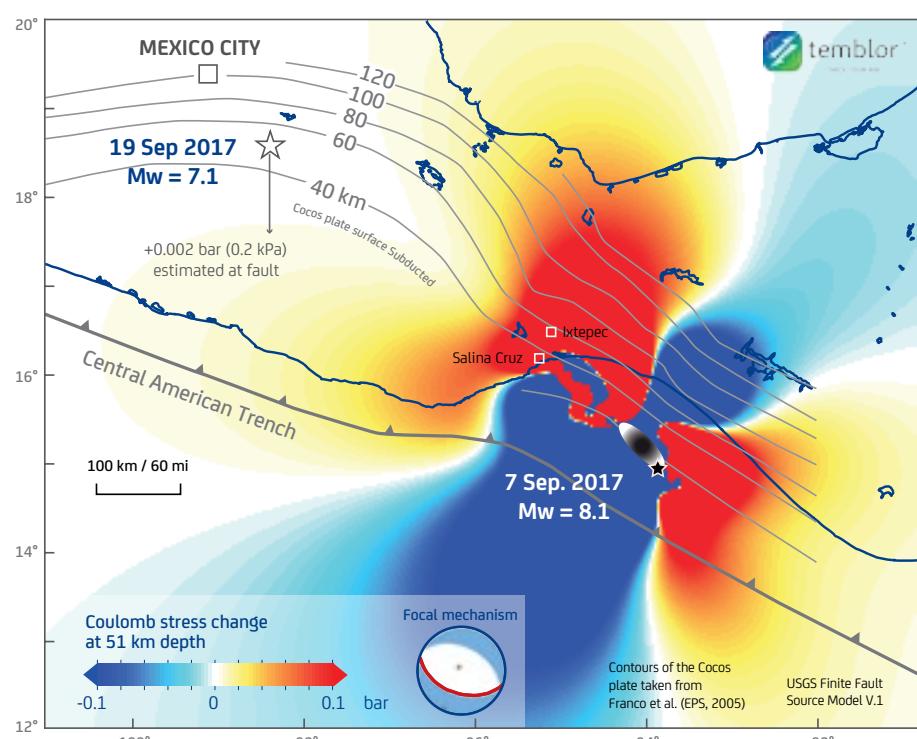
⌚ The increase in stress generated by the Chiapas earthquake (Mw = 8.1) corresponds to the strongest colors, while the lighter colors indicate a very low or even negligible incidence of the earthquake in those regions.

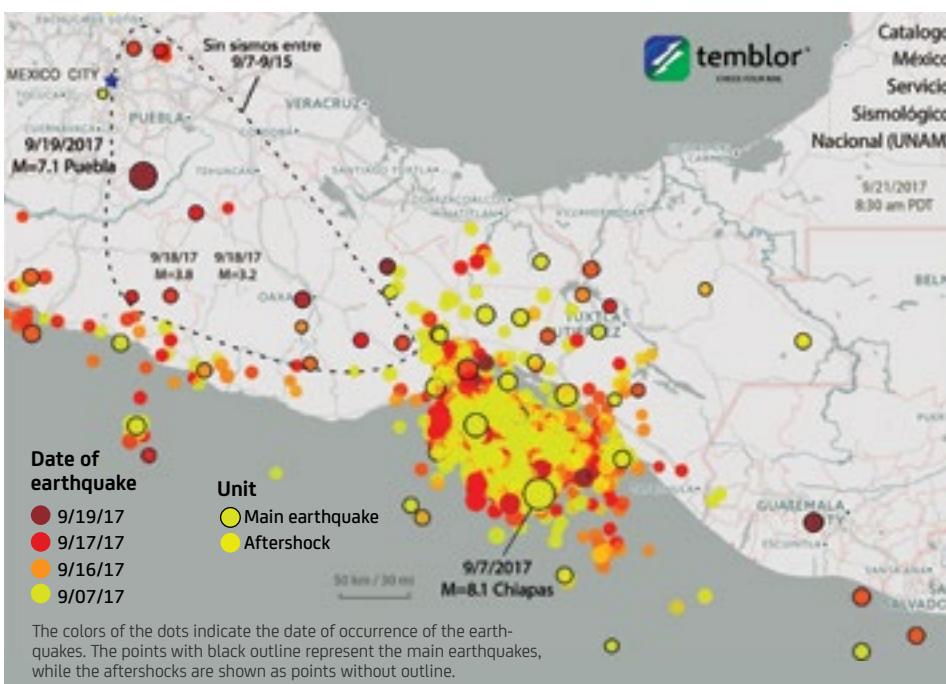
### ⌚ Location of the earthquakes registered in Mexico between September 7 and 19.

The colors of the dots indicate the date of occurrence of the earthquakes. The points with black outline represent the main earthquakes, while the aftershocks are shown as points without outline.

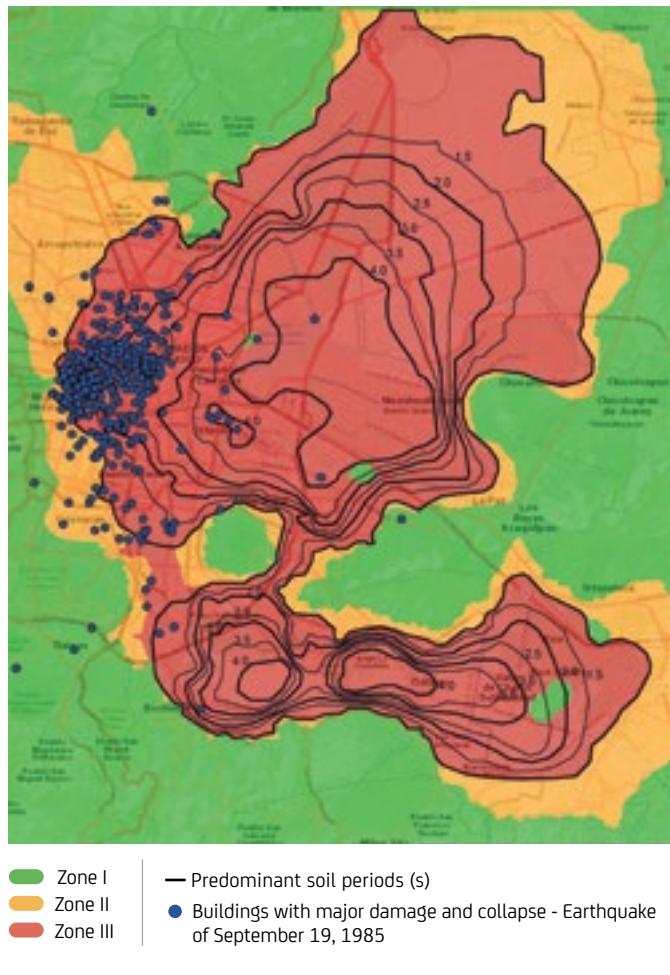
Damage map of the 1985 earthquake on seismic zoning of Mexico City in 1976

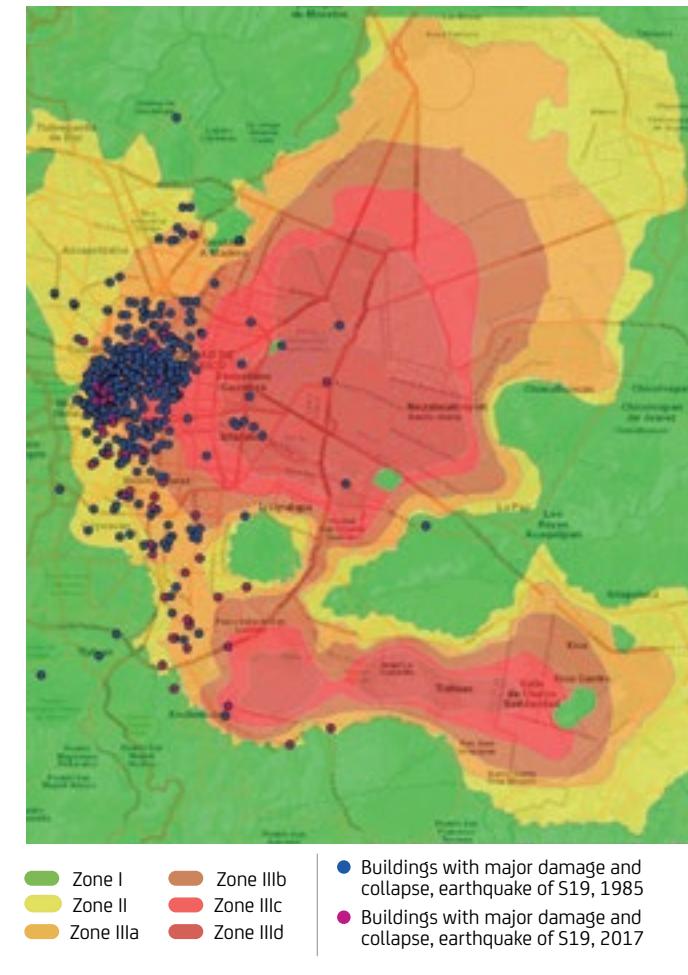
Damage map of the September 19, 1985, and 2017 earthquakes on seismic zoning of Mexico City 2004

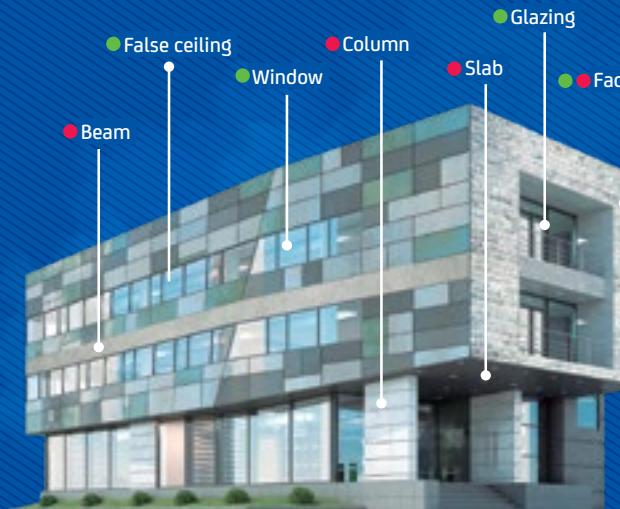
- ⇒ The field information survey conducted in stage 1 involves the identification of the structural and non-structural elements of the buildings, as well as the assessment of the respective damages.

#### Structural

#### Non-structural

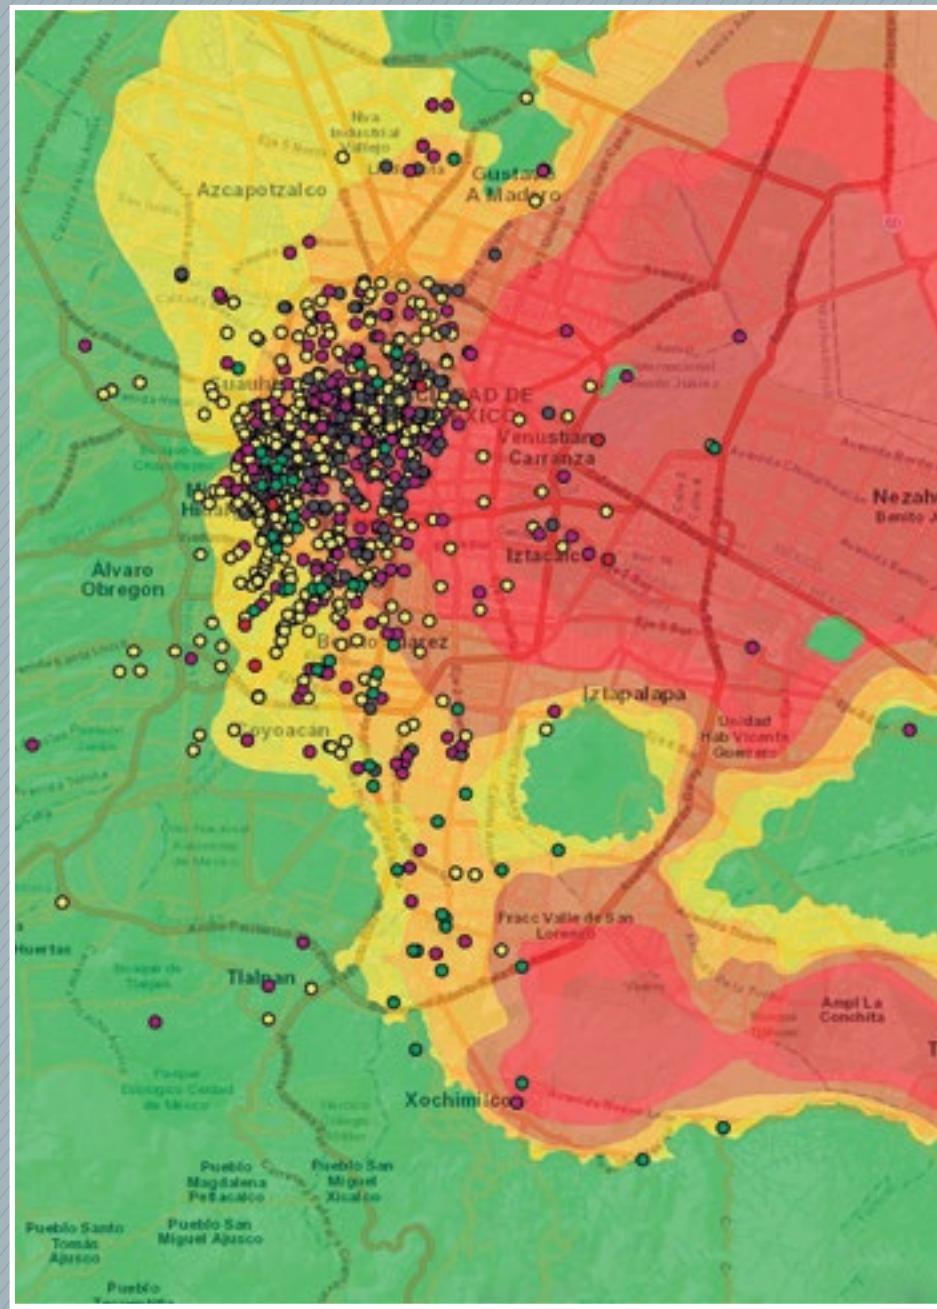
## ⬇ Building damage distribution reported by official sources, 1985 and 2017 earthquakes of September 19, 1985 and 2017

The distribution of collapses of 19S 2017 reported in the brigades' collaborative map indicates that these were concentrated in buildings of less than 10 stories, built before 1985, with flat slab typologies, masonry and reinforced concrete frames. Compared to the 1985 earthquake of September 19, 1985, 45% of the collapses and severe damage occurred in concrete frame buildings and flat slab systems between 6 and 10 stories.

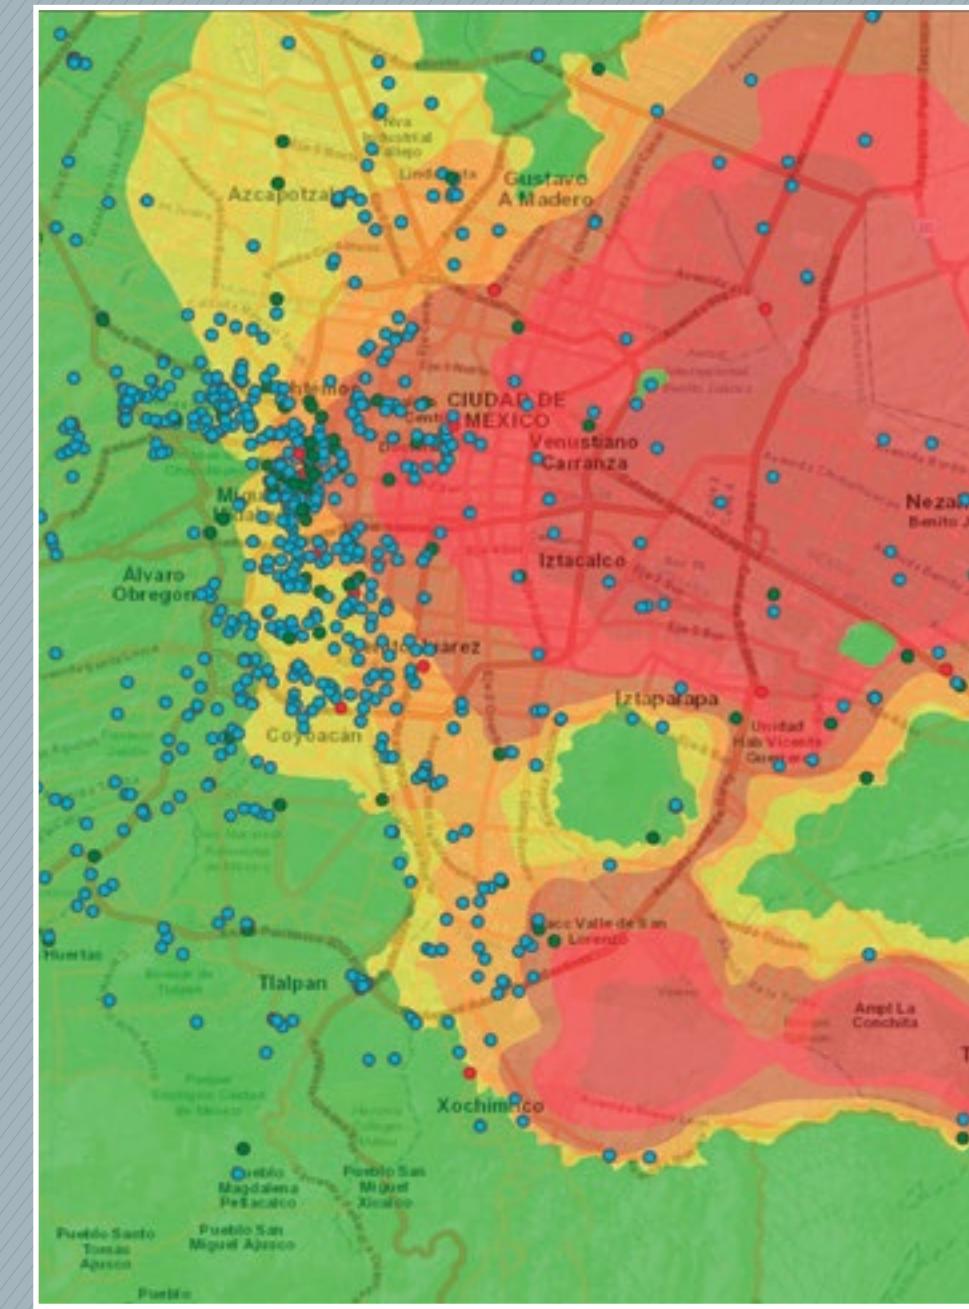
## ⬇ Distribution of damages in buildings inspected by Sura, earthquake of 19S 2017

From the group of buildings inspected by SURA, 192 were classified with special damage or risk of collapse, of which 65% are concentrated in masonry systems, reinforced concrete frames (filled with non-structural walls) and flat slab systems of less than 10 levels. In addition, from this group of buildings it was found that the irregular configuration of the structures, such as corner locations and weak floors, has a marked influence on the generation of earthquake damage.

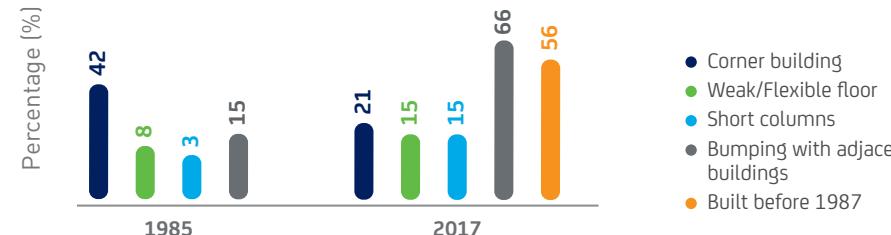
⌚ Structural characteristics of buildings with major damage and collapse caused by the 1985 and 2017 earthquakes of September 19, 1985 and 2017

→ The same building may have none, one or several of these characteristics

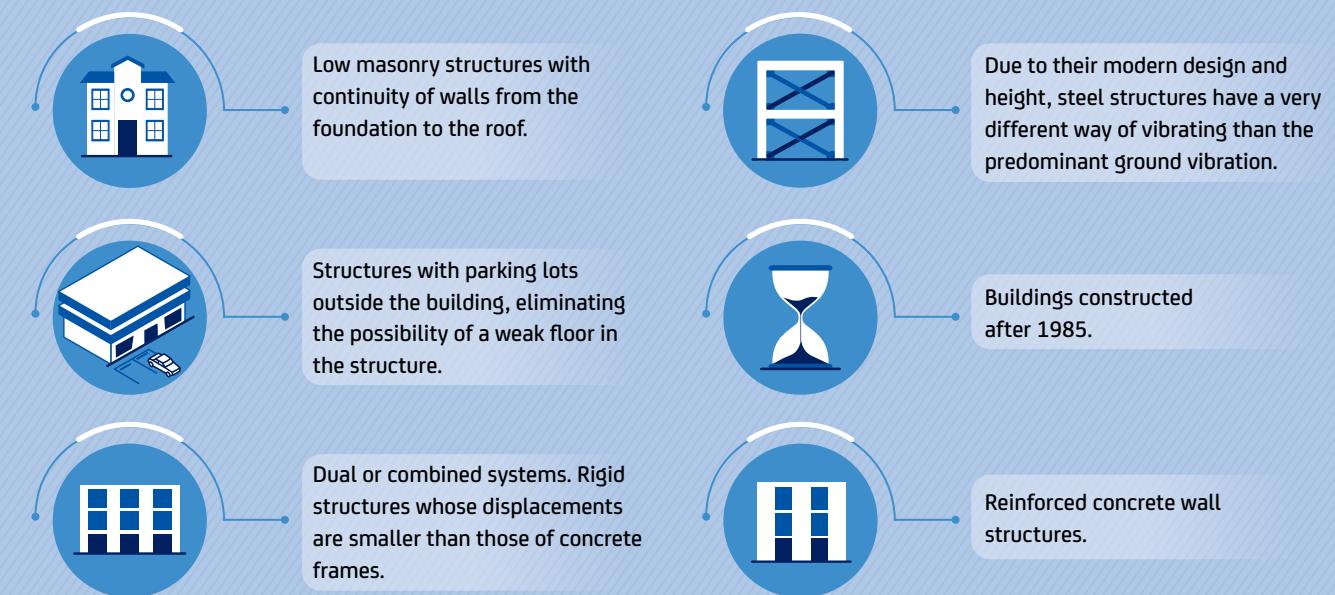
#### Structural systems with better performance during the 19S earthquake of 2017

The 19S earthquake of 2017 shows that the damage to buildings depends to a large extent on the structural system and the area where the building is located. Suppose a detailed analysis is carried out that considers which structures behaved adequately in Mexico City, both in the 1985 earthquake and the 19S earthquake of 2017. In that case, it could be easily concluded that dual and combined systems were some typologies that had a better seismic performance.

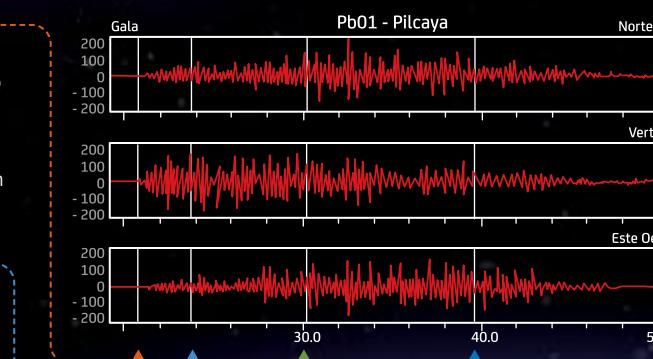
### 2SP ESTIMATOR

The third algorithm monitors seismic wave conditions from the time P-wave motion is detected until a significant S-wave phase.

At the instant when the sensor registers the S-waves of the earthquake, the second algorithm is executed, in which the signal of the frequency and energy content of the P-waves registered up to that instant is sent.

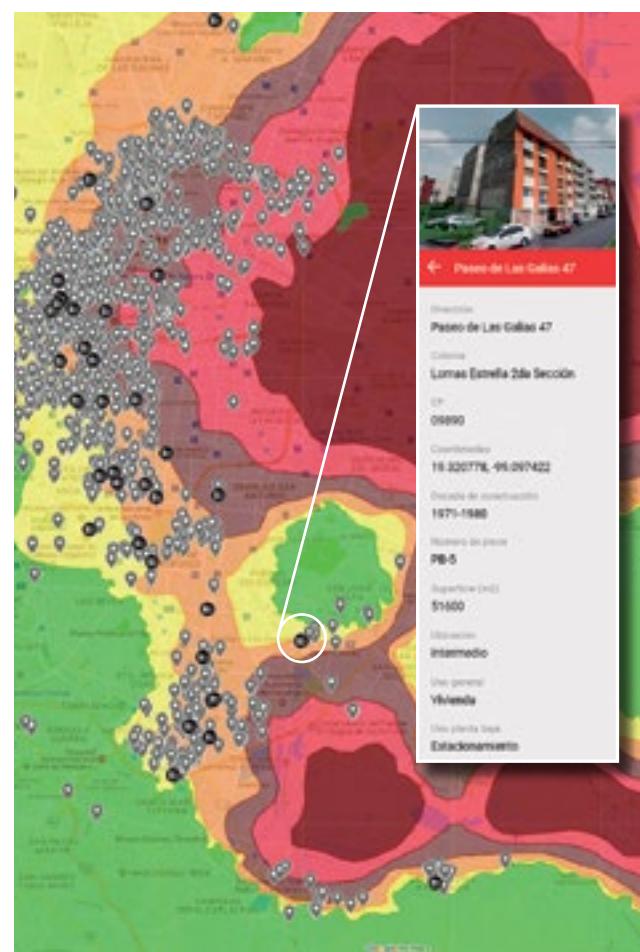
↓ Collaborative map with information collected by the brigades of civil engineers in Mexico City

Map focused on technical specialists  
[www.sismosmexico.org/mapas](http://www.sismosmexico.org/mapas)

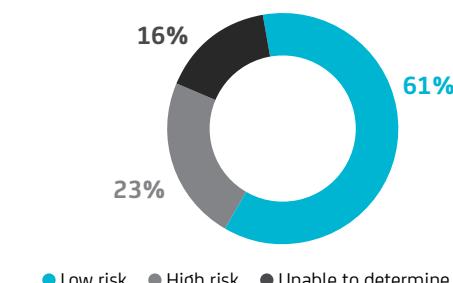
↓ Damage classification - Buildings inspected by the brigades

CLASIFICATION	BUILDINGS
Low risk	1,210
High risk	460
Unable to determine	327
<b>TOTAL</b>	<b>1,997</b>

Preliminary summary of damages of the buildings inspected by the brigades of the earthquake of 19/09/2017.  
(<https://www.sismosmexico.org/informes>)

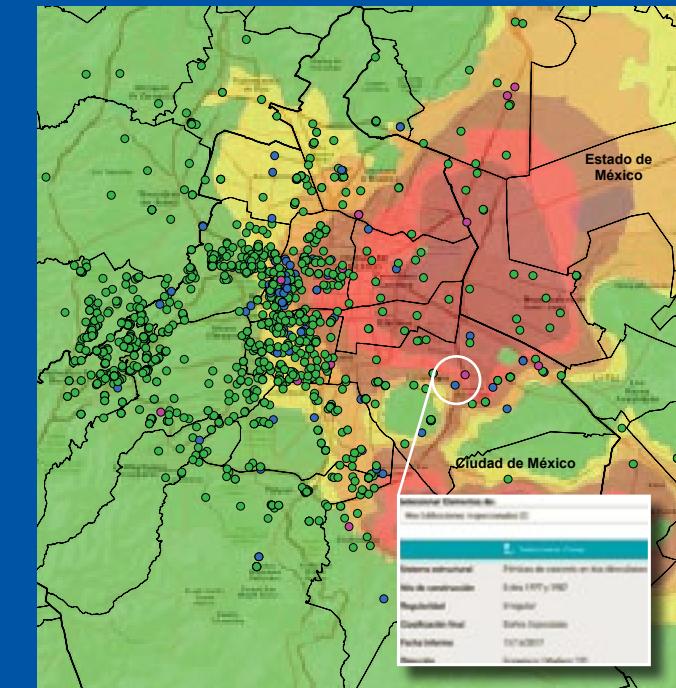
↓ SURA map with information collected by structural engineers in Mexico City

Buildings inspected by Sura  
● Risk of collapse   ● Special damages   ● Minor damages  
Seismic Zoning of Mexico City  
■ Zone I   ■ Zone IIIa   ■ Zone IIIc  
■ Zone II   ■ Zone IIIb   ■ Zone IIId

Map with damage classification of buildings inspected by SURA  
- Taken from the tool GeoSURA

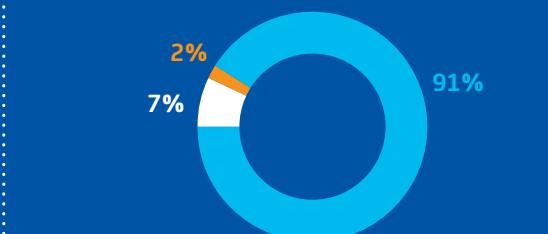
↓ Damage classification - Buildings inspected by SURA

CLASIFICATION	BUILDINGS
Minor damages	2,002
Special damages	157
Risk of collapse	35
<b>TOTAL</b>	<b>2,194</b>

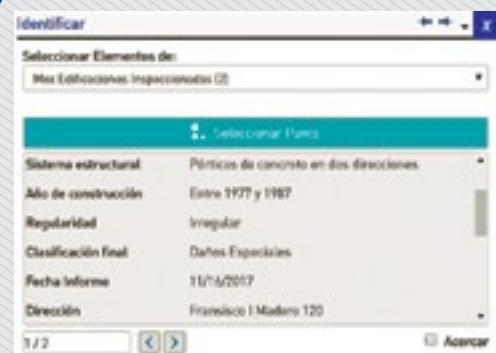
Thanks to the functionalities of the GeoSURA platform, it was possible to spatially cross-reference the available information to identify the most affected zones.

## GeoSURA, platform for seismic event management

SURA's corporate geographic information platform - GeoSURA, facilitated the identification of the event, the affected areas and the policyholders that would potentially have some level of damage.

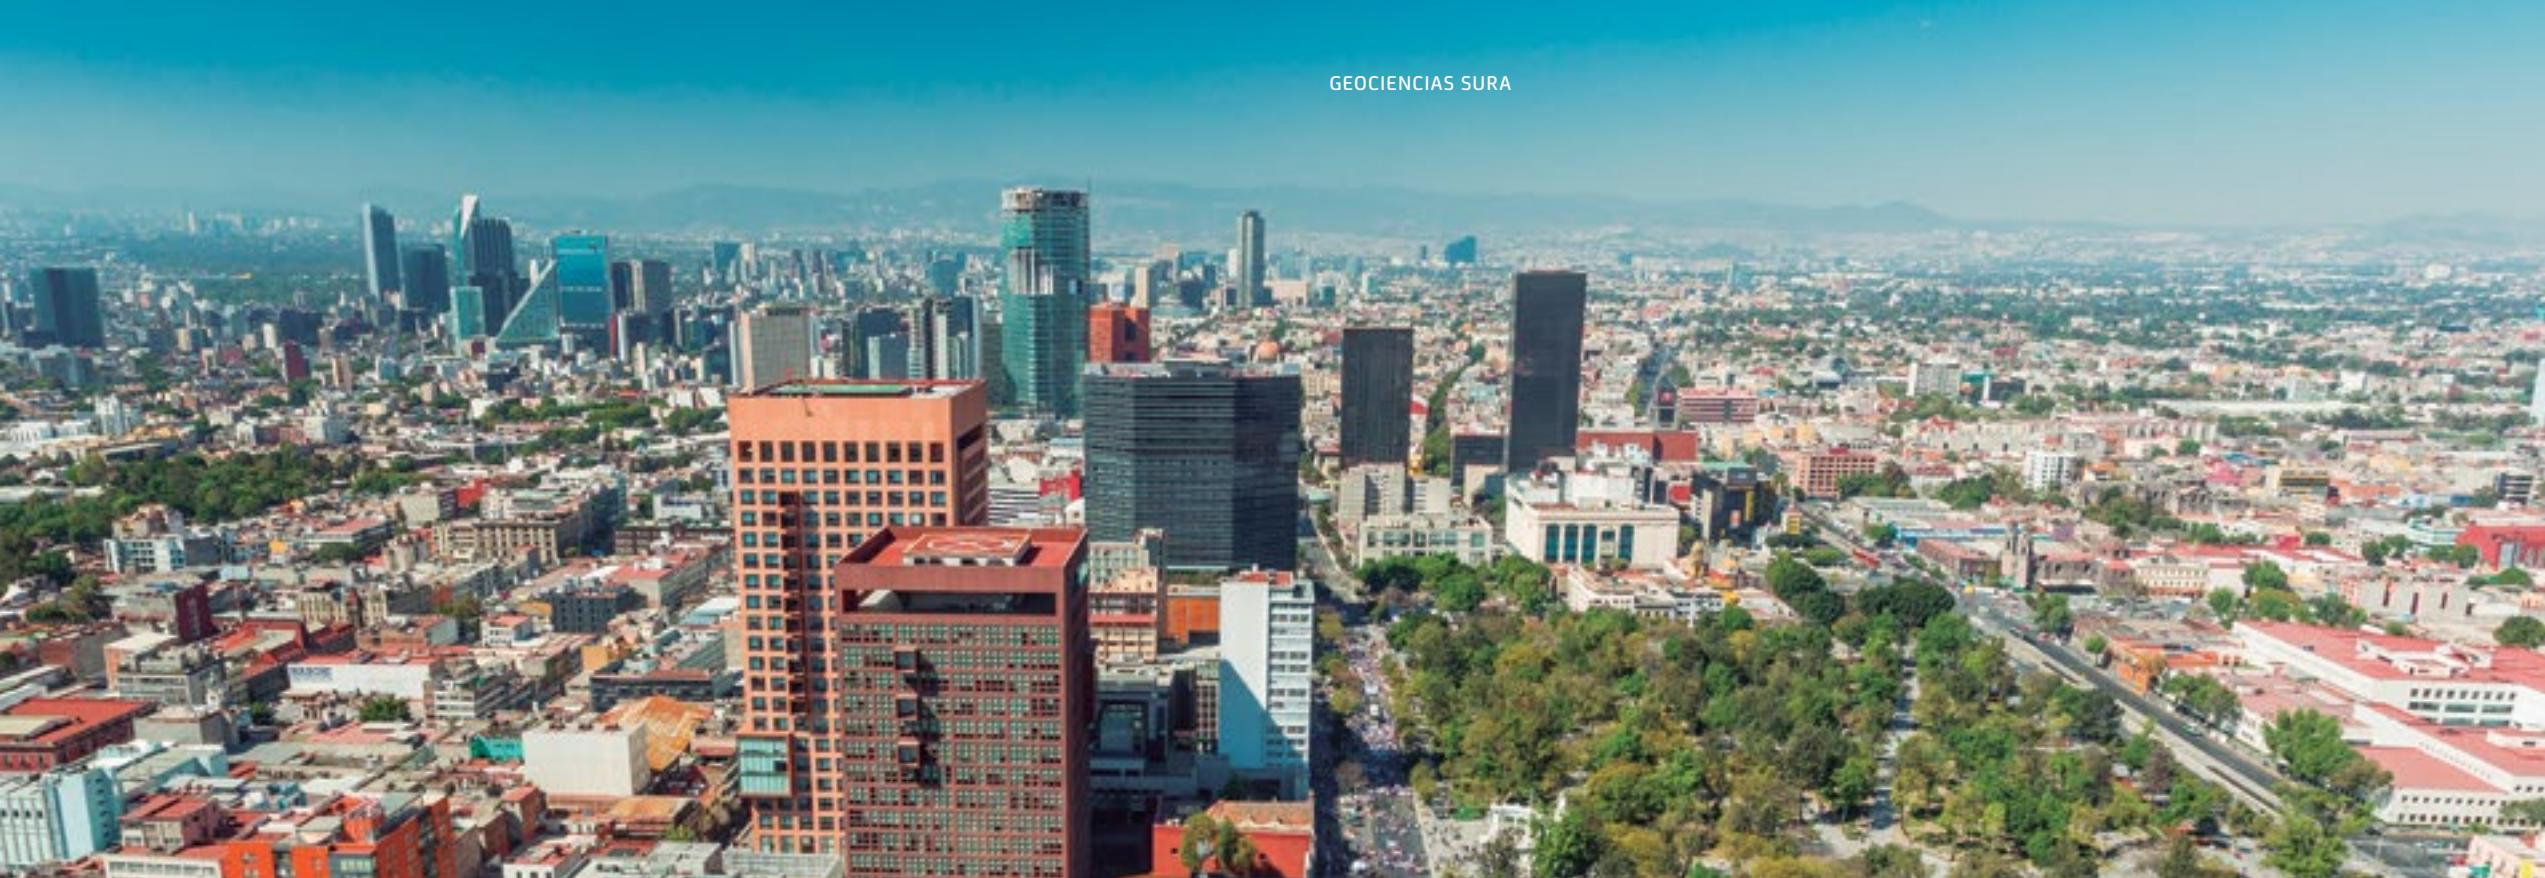
Important positive feedback from the 19S earthquake of 2017 was the good performance of buildings with dual-type structural systems. The results of the calculation of the damage index proposed by Ph.D. Mario Rodriguez indicate that even considering the joint effect of the 1985 and 2017 earthquakes, buildings with dual system have no collapse potential, which is also congruent with the absence of collapses of buildings of this typology related to the 19S earthquake of 2017.
